Holly Lake Ranch
Mr. Rob James
220 Holly Lodge Circle
Holly Lake Ranch, TX 75765

18 May 2011

I conducted my May site visit to treat vegetation and collect water chemistry data from the big lake at Holly Lake Ranch on 17 May 2011. Water chemistry parameters fell within the acceptable or desirable ranges. From a fish and wildlife perspective the lake continues to look very good. There were lots of active bream beds observed. There were also lots of forage fish along the shore and amongst vegetation and docks. There was less coontail scattered around the lake that was treated during the April treatment, but more filamentous algae than the two previous visits. No trash was observed in the lake.

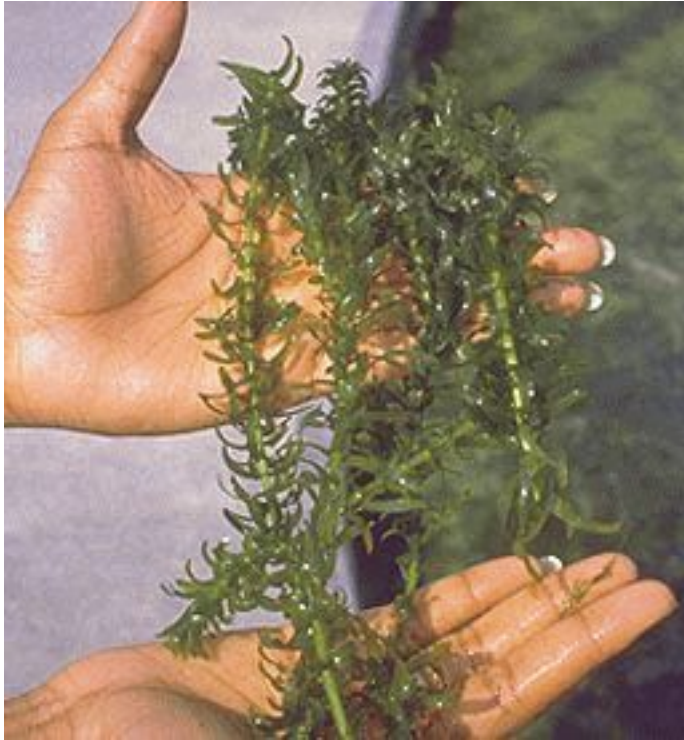
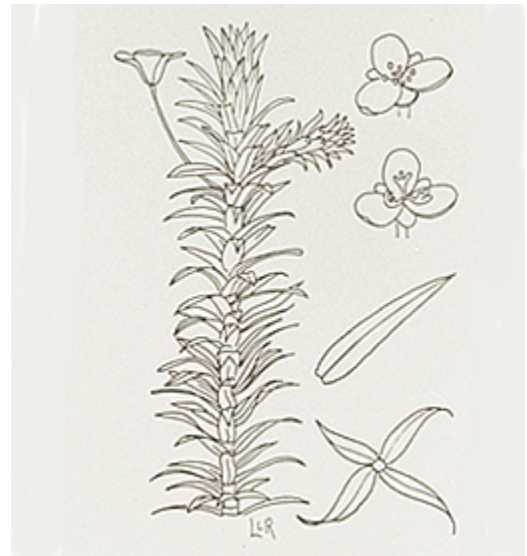
Egeria Description

As I stated earlier the new plant species does look like Hydrilla, but I am sure what we have seen to date is Egeria. It is a non-native species and can grow aggressively. Below I have included some additional information compiled by Texas A&M University regarding the plant. It either washed in from upstream or was brought into the lake by boat trailer. It is a common aquarium plant, but I am not sure it can still be purchased today for aquariums. I will order another herbicide (I believe I will use Aquathol granular) type this week and have it ready for June. I have a call into our herbicide supplier for his input prior to ordering. Since much of this plant is submerged a granular will work better on the small submerged patches.

Egeria is native to South America but has become naturalized in much of the Southeastern U.S. Egeria is a rooted perennial plant but can survive and grow as floating fragments. The dark green lance-like leaves are in whorls of 4 to 6 which become more dense near the tip of the stem (near the surface). Leaves are about 1/2 inch wide and from 3/4 to 1 1/4 inches long with finely toothed margins. Flowers are white about 3/8 to 3/4 inches in diameter on short stalks which commonly are emergent.

Egeria is often confused with the native Elodea or the non-native Hydrilla. Hydrilla has one or more teeth on the underside of the midrib, neither Elodea nor Egeria have these midrib teeth. The teeth make Hydrilla feel rough when drawn through your hand from base to tip. Flowers of Egeria are larger than Hydrilla. Egeria leaves are larger than elodea and in whorls of 4 to 6 and not 3 as with elodea.
